Doubletree Hotel Fire New Orleans, Louisiana

Doubletree Hotel Fire New Orleans, Louisiana (July 19, 1987)

Investigated by: Jeffrey M. Shapiro, P.E.

**This is Report 008 of the Major Fires Investigation Project conducted
by TriData Corporation under contract EMW-86-C-2277 to the United
States Fire Administration, Federal Emergency Management Agency.**

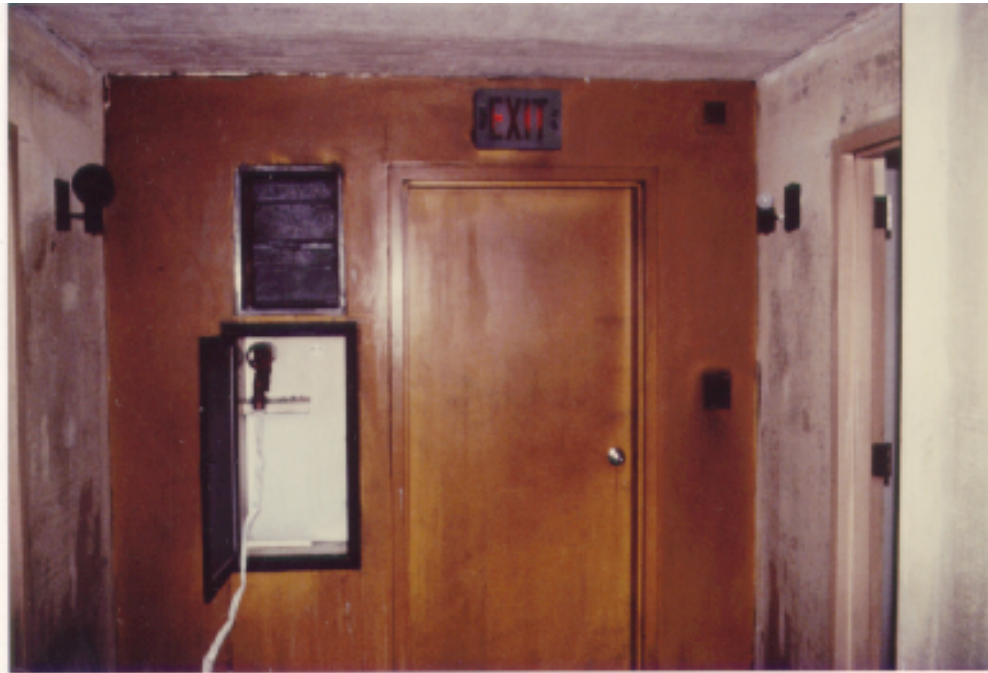
Figure 4. View of short corridor from area of origin toward Stairway 1 -- 9th floor.

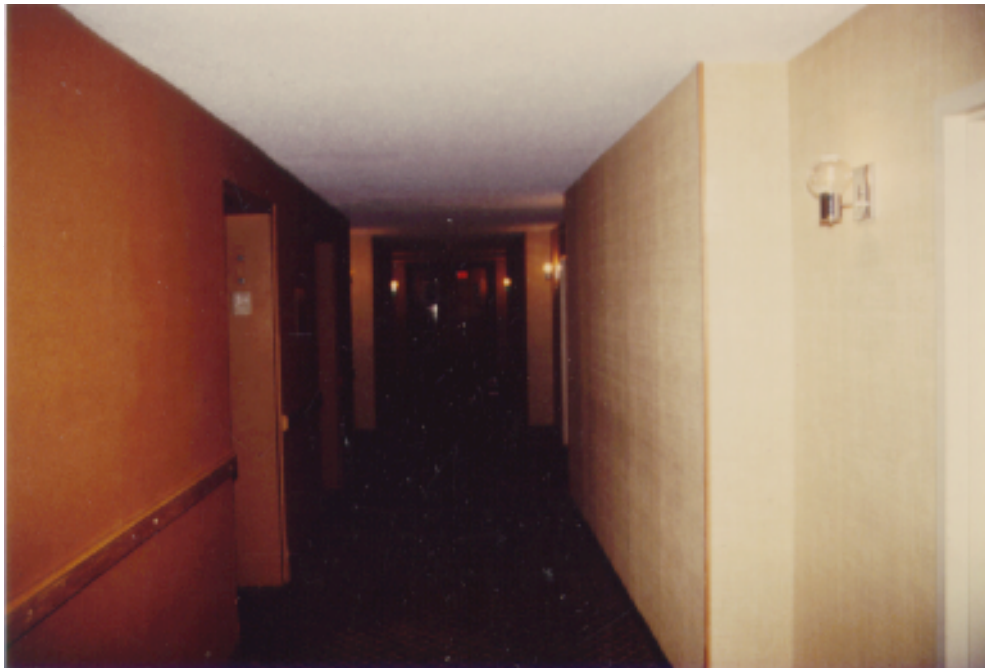
Figure 5. Entrance to exit Stairway 1 -- 10th floor. Note the ventilator opening (upper left) and fire hose/extinguisher cabinet (lower left).

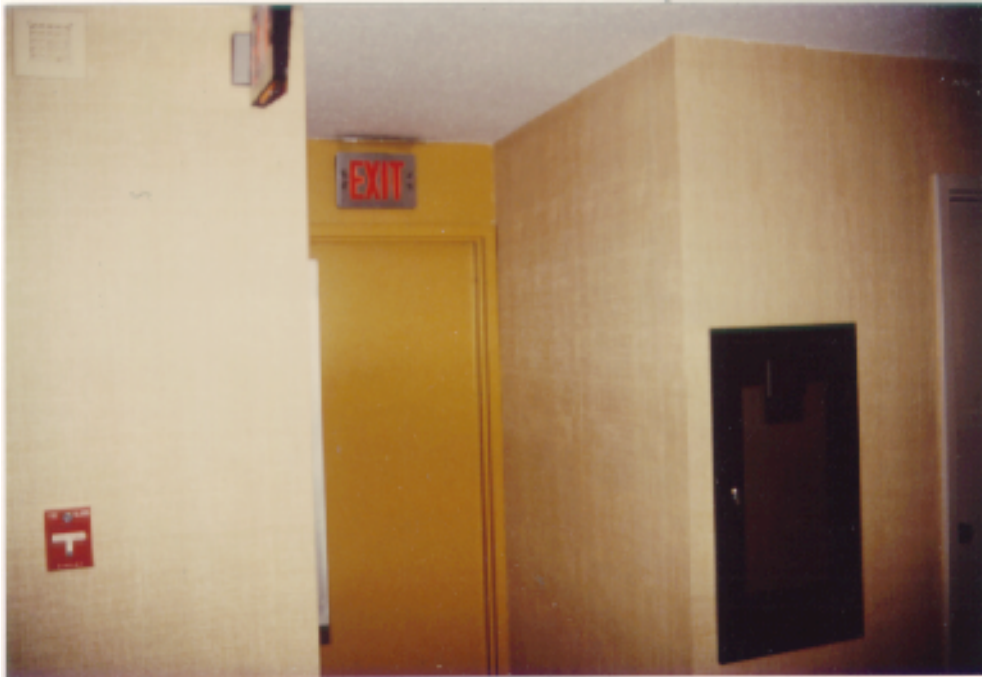
Figure 6. Entrance to exit Stairway 2 -- 9th floor.
Compare with Figure 7 after fire.

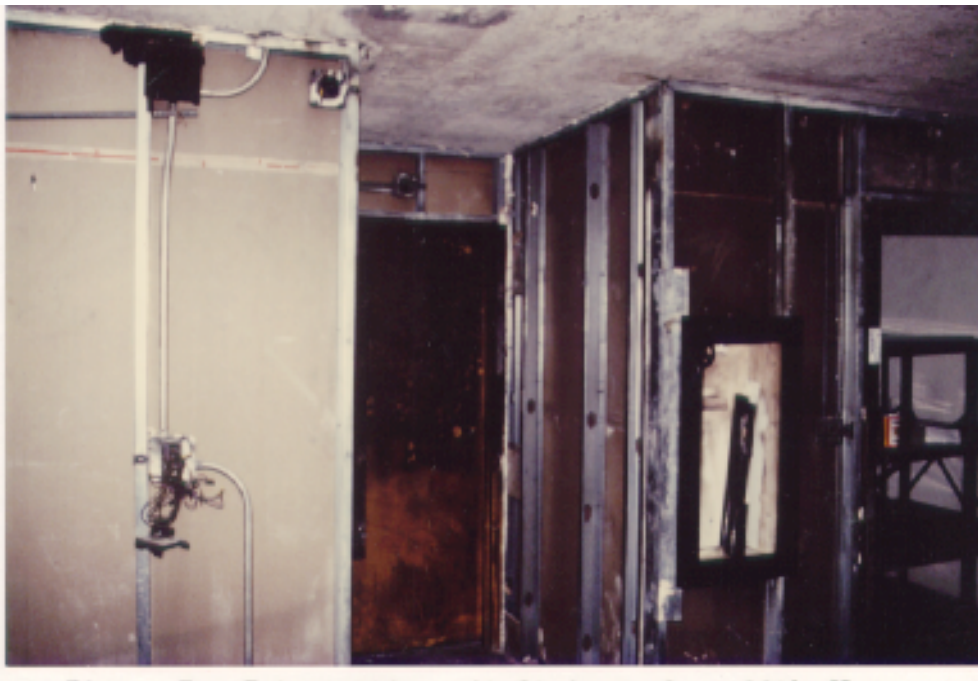
Stairway 2 because the manual alarm was only activated at a single location -- on the tenth floor immediately adjacent to Stairway 2 (see Figures 6 and 7). Given conditions likely to be present on the tenth floor at this point, it is assumed that the guard would have pulled the alarm as quickly as possible. The timing of the guard initiating the alarm in this sequence is relatively consistent with the other aspects of this scenario, since the family who had exited the ninth floor before the alarm had sounded began to encounter other guests entering the stairwell one or two minutes after leaving the ninth floor. This would have been enough time for the guard to go into Stairway 1, double back to Stairway 2, and get to the tenth floor.

Figure 7. Entrance to exit Stairway 2 -- 10th floor.
Note pull station at left used to initiate
local alarm by guard.

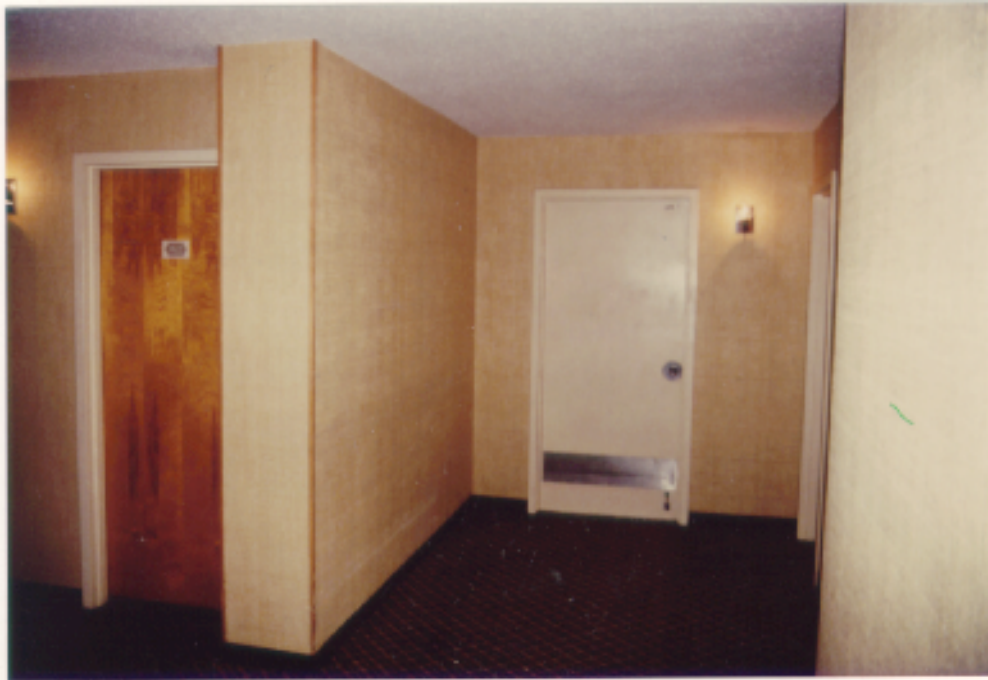
Figure 8. Area of origin on 9th floor, for comparison.

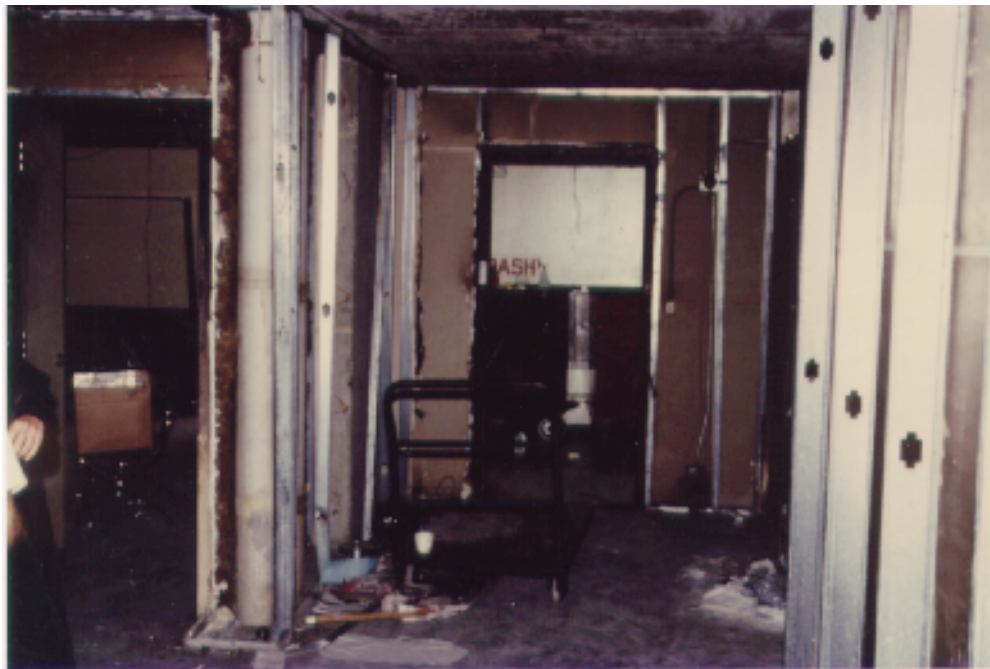
The fire is estimated to have originated sometime between 10:00 p.m. and 10:15 p.m. and is believed to have been caused by arson. The Fire Department determined that there were no other possible ignition sources present and that there was no possibility of an accidental smoldering fire because an eleventh-floor guest had been on the tenth floor to get ice less than ten minutes before the fire alarm sounded and had detected no sign of a fire. Figures 8 and 9 show the area of origin.

Figure 9. Area of origin on 10th floor.

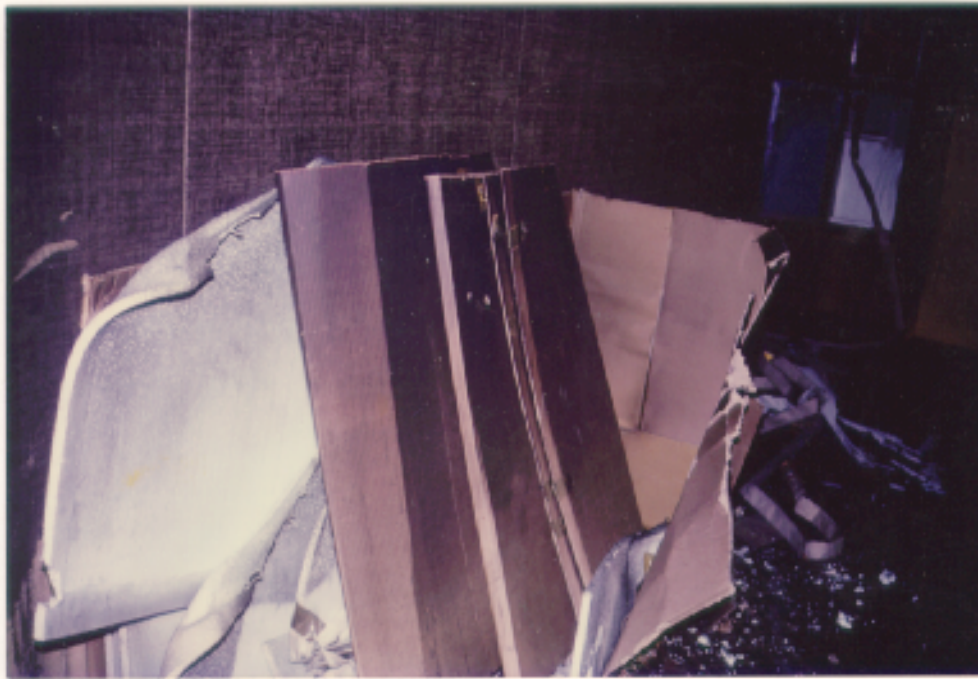
Figure 10. Debris similar to that involved as first material ignited -- 10th floor.

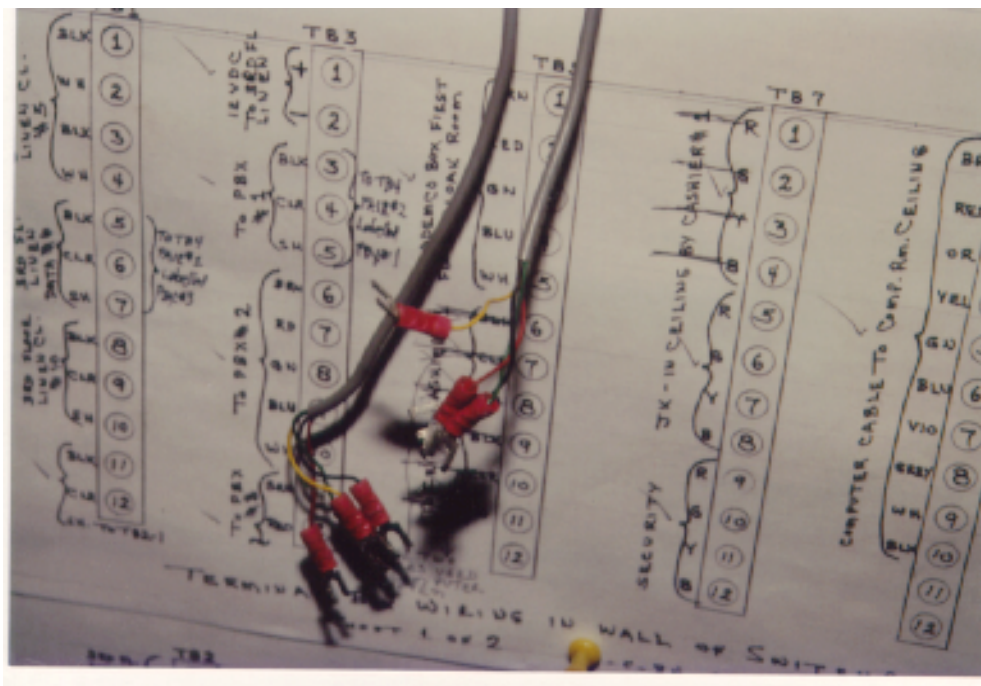
Supervisory Service," and NFPA 72E, "Standard on Automatic Fire Detectors," published by the National Fire Protection Association. Although the system had been partially dismantled at the time of this investigation, it is still fairly conclusive that the automatic alarm failed to operate. A representative of the Fire Department -- assisted by representatives of a local fire alarm company -- attempted to activate the system by blowing smoke into the system's smoke detectors on the day after the fire but was unable to cause an alarm even though the photocell light sources were illuminated. This suggests that smoke detectors probably were not connected to the alarm panel or that the panel had malfunctioned. Furthermore, the automatic alarm system did not appear to connect to any audible alarms, nor did it appear to connect with the manual system, which had audible devices. Therefore, it seems that even if the smoke detectors had been able to detect a fire and the control panel had been functional, the system may only have been capable of indicating a fire at the control panel, which was located in an unoccupied closet on the third floor. Additional significant deficiencies included the use of telephone wire connecting all initiating devices to the control panel, and the placement of all corridor smoke detectors in "dead air" locations in the corridor (within 4 inches of a wall); see Figures 11 and 12 for detector locations.

Figure 11. Telephone wire used for automatic fire alarm system, security system, and public address system.

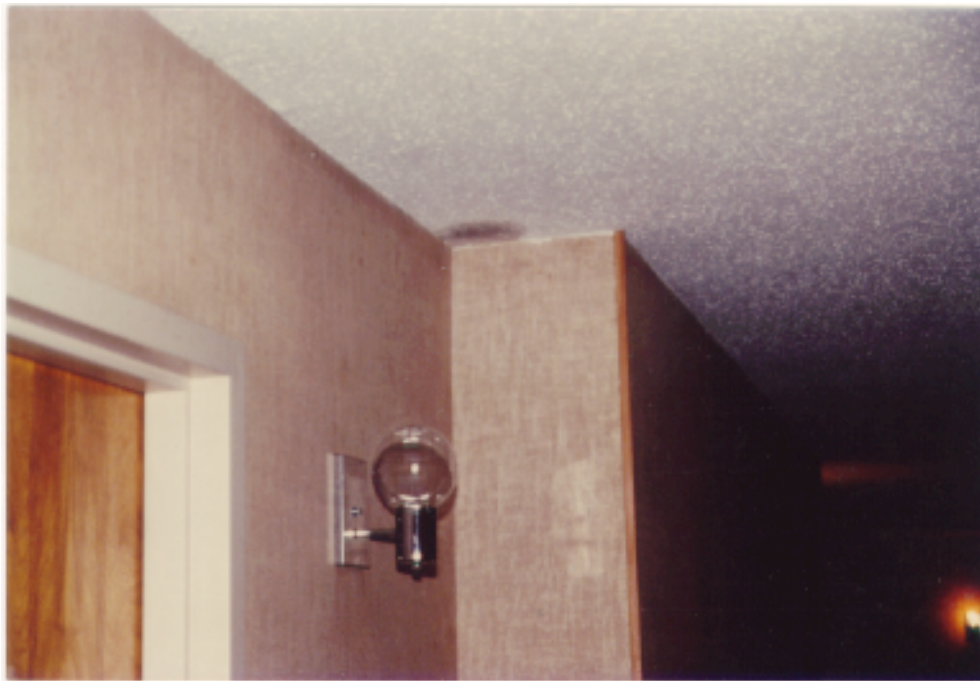
Figure 12. Location of corridor smoke detector (dark spot on ceiling).

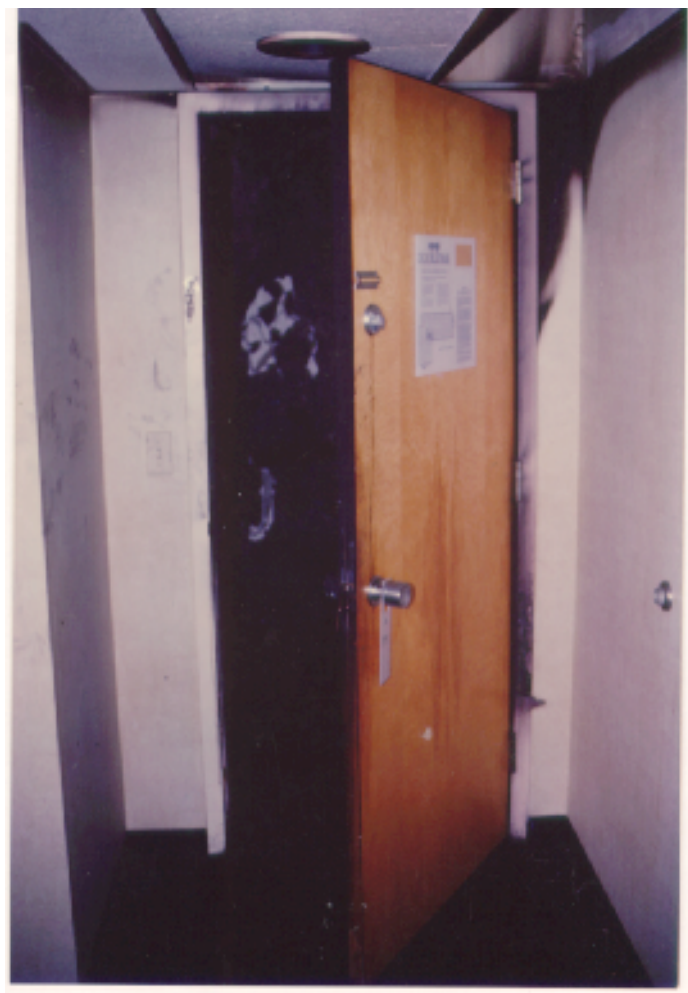
Figure 13 Guest rooms on 10th floor sustained minimal damage due to performance of doors.

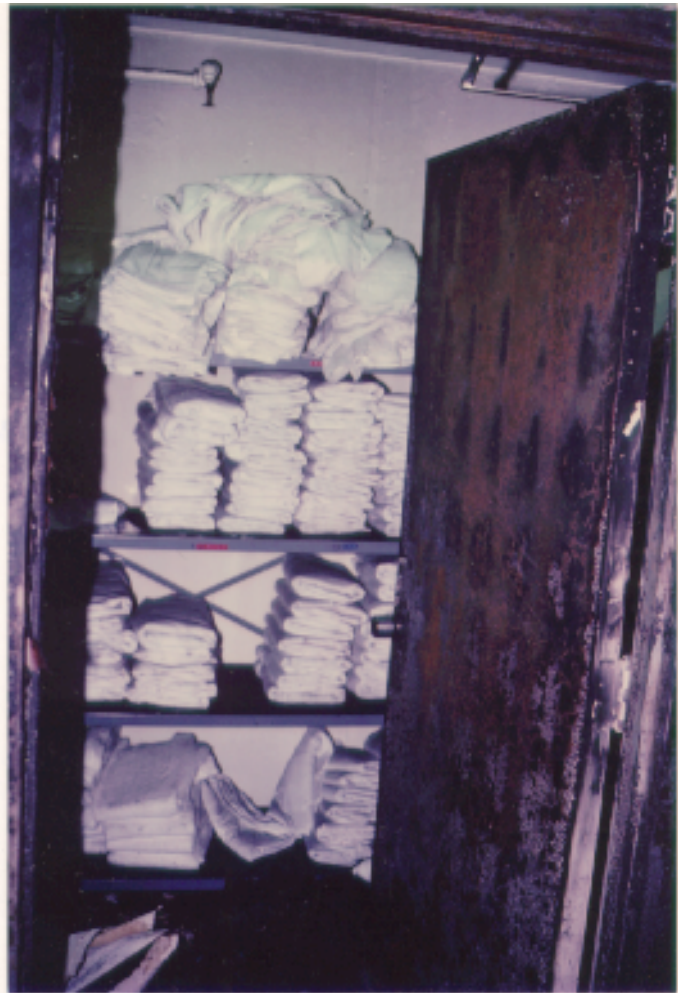
**Figure 14. Fire door protected
linens in closet
only 20 feet from
area of origin.**

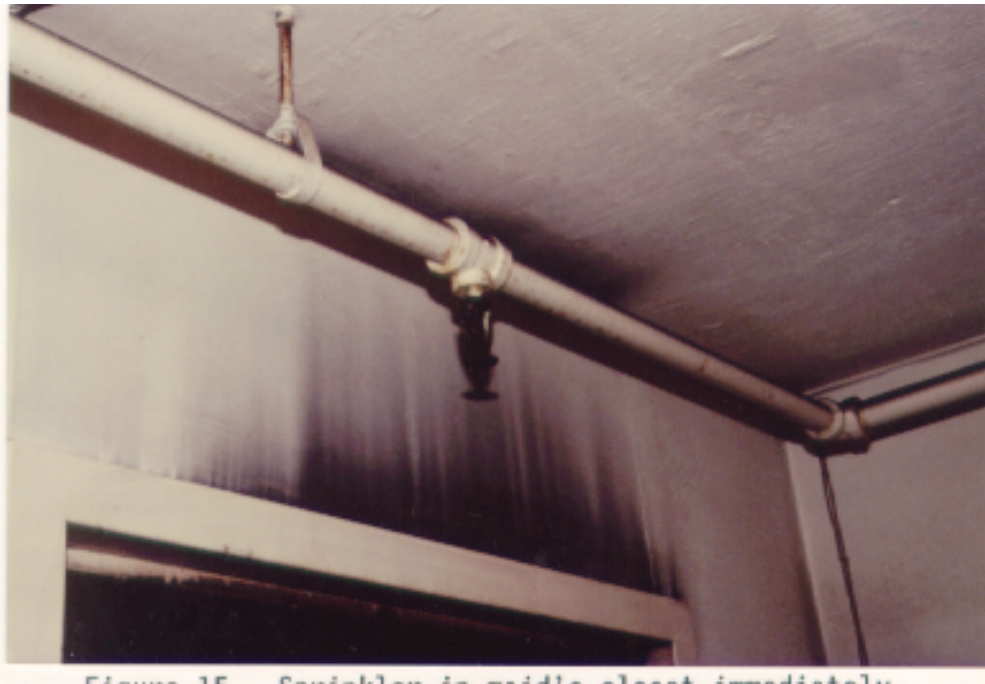
Figure 15. Sprinkler in maid's closet immediately

**adjacent to area of origin was not
activated due to performance of fire door.**
